Manhole Inspection Summary

Manhole # S21WW1015MH

Insp Date: **5/8/07 1:23 PM**

Location Address: **5203 FAIS RD**

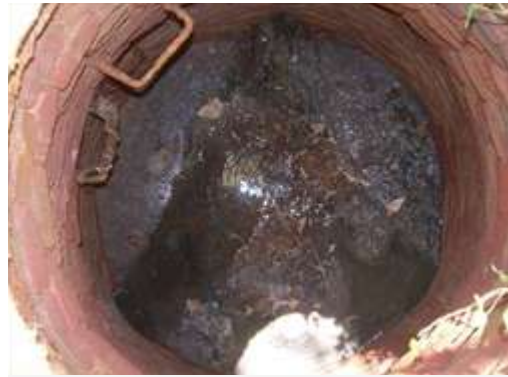
Top View

Corroded steps. Evidence of surcharge - Bench debris. Channel debris.

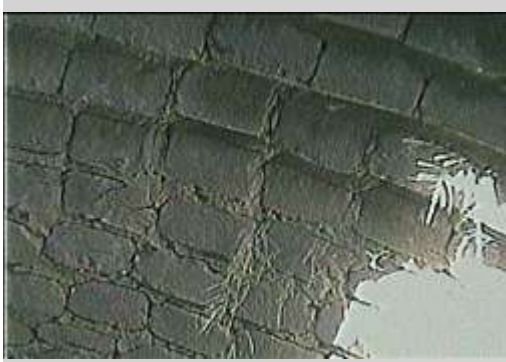
Defect

Condition: ☐ Sound ☐ Cracked ☒ Root Intrusion ☐ Loose Brick ☒ Deteriorated

Infiltration: ☐ None ☐ Joint ☐ Cracks ☒ Mortar ☒ Roots ☐ Wall

Barrel deterioration, root intrusion and infiltration.

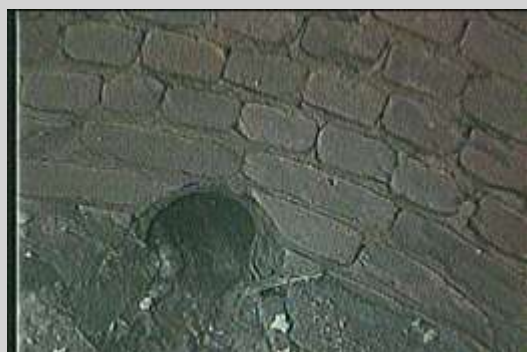
Pipe Out @ 12 O'Clock

Deposits: ☐ None ☒ **Mud** ☐ Sludge ☒ **Debris** ☒ **Grease**

Silt Depth: **1** (in.) Deposits Extent: **Light**

Infiltration: **Evidence** Pipe Seal Cond: **Broken**

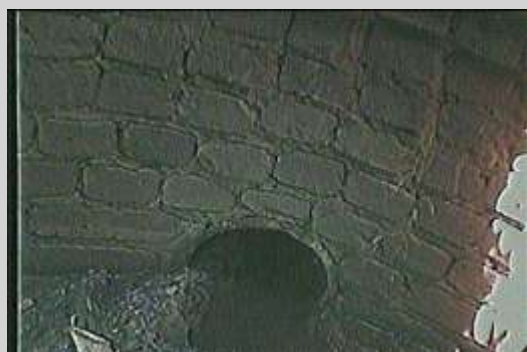
Pipe In @ 5 O'Clock

Deposits: ☐ None ☒ **Mud** ☐ Sludge ☒ **Debris** ☐ Grease

Silt Depth: **1** (in.) Deposits Extent: **Medium**

Infiltration: **Evidence** Pipe Seal Cond: **Cracked**

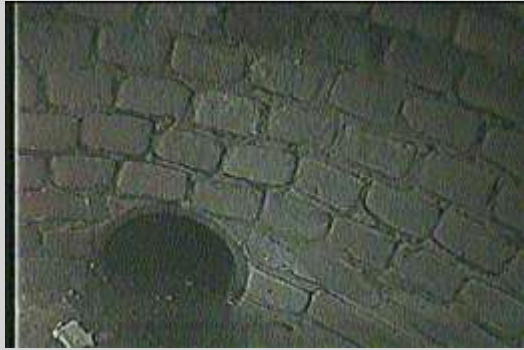
Pipe In @ 8 O'Clock

Deposits: ☐ None ☒ **Mud** ☐ Sludge ☒ **Debris** ☐ Grease

Deposits Extent: **Medium**

Infiltration: **Evidence**
